## Sudden disconnection of pressurised hose

Safety Flash Published on 17 December 2024 Generated on 10 January 2025 IMCA SF 24/24

A contractor was performing maintenance on the bulk cargo methanol system on deck of a vessel.

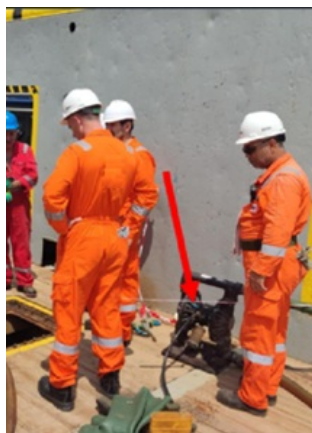
Residual water was being pumped out from a cofferdam when a pressurized hose suddenly disconnected. The system pressure was approximately 5.9-6 bar, creating a potential risk of injury to personnel. Fortunately, no one was in the line of fire, and no contact was made. There were no injuries or property damage from this incident.

- There was no secondary securing system – no whip check arrestor – installed, even though this was specified in the task risk assessment.
- No-one checked the equipment before starting the job.
- No-one stopped the job.
- The hose end coupling itself appeared as worn out, and this was unnoticed.
- There were no whip arrestors and hose tail couplings available, neither on the vessel or with the contractor doing the work.

Disconnected hose end connection

Showing pump

- Ensure there is sufficient equipment and spares on board to do a safe job – the lack of even a very small part can lead to something being unsafe.
- Ensure pressurised hose connectors have secondary securing – whip arrestors.
- Check your equipment before you start work – it only takes a few seconds. Check the condition of hose end couplings on pressurized equipment, and identify any wear or damage that could compromise their integrity during usage.
